Alert Service Bulletin No. 069

200F, 201F, 202F Fuel Pump Leak Inspection and Diaphragm Replacement

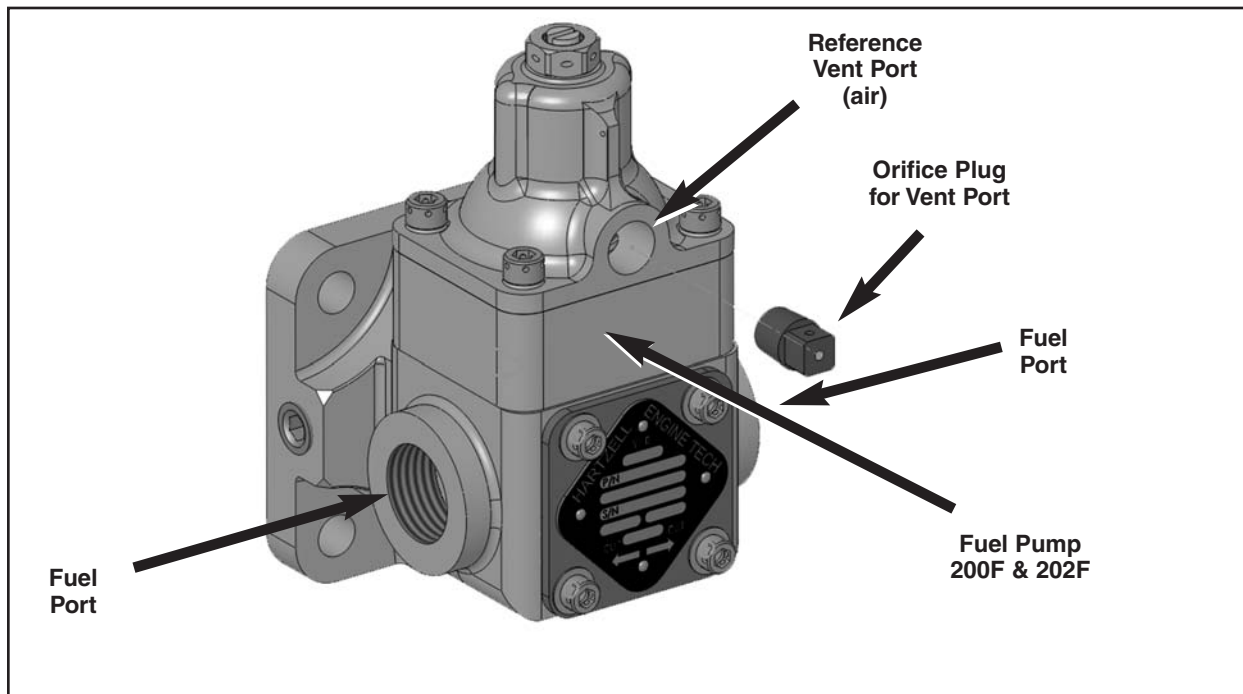
Figure 1 - 200F & 202F Identification

- (a) Inspection of the orifice plug requires only a visual inspection. Look around the plug and into the orifice for fuel or blue dye stains. Refer to Fig. 1 or Fig. 2.

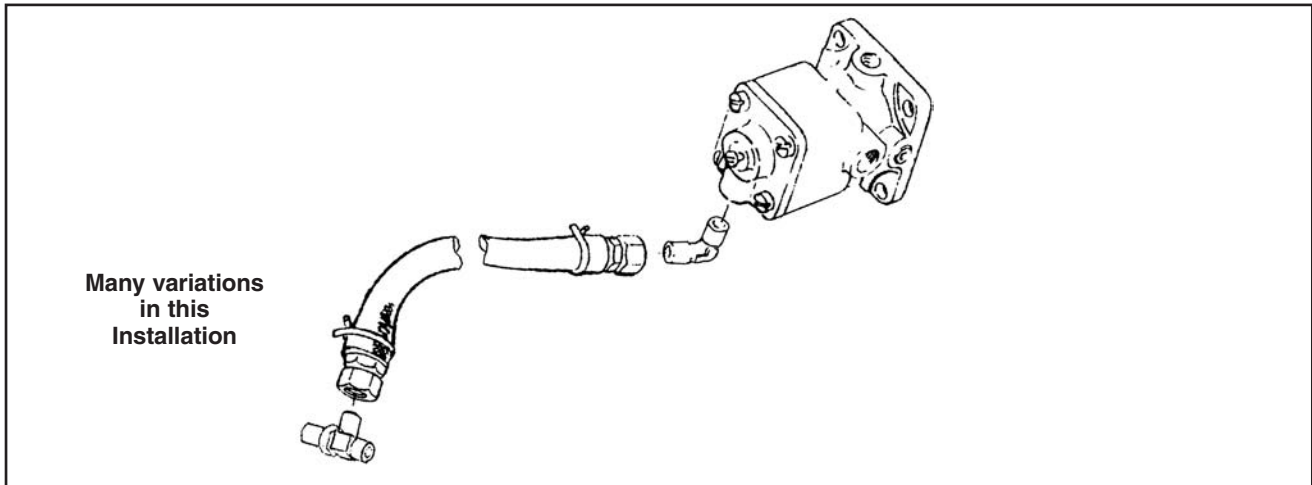
Figure 5 - Typical HET 201F Fuel Pump Plumbed to Upper Deck Reference

- (b) Inspection of the upper deck reference line requires that the line be disconnected and the inside of the fitting be inspected for fuel or blue dye stains. Refer to Fig. 5 and 6.
