Service Bulletin

Bulletin No. 041 Rev. A

201F Fuel Pump Shaft Seal Leak

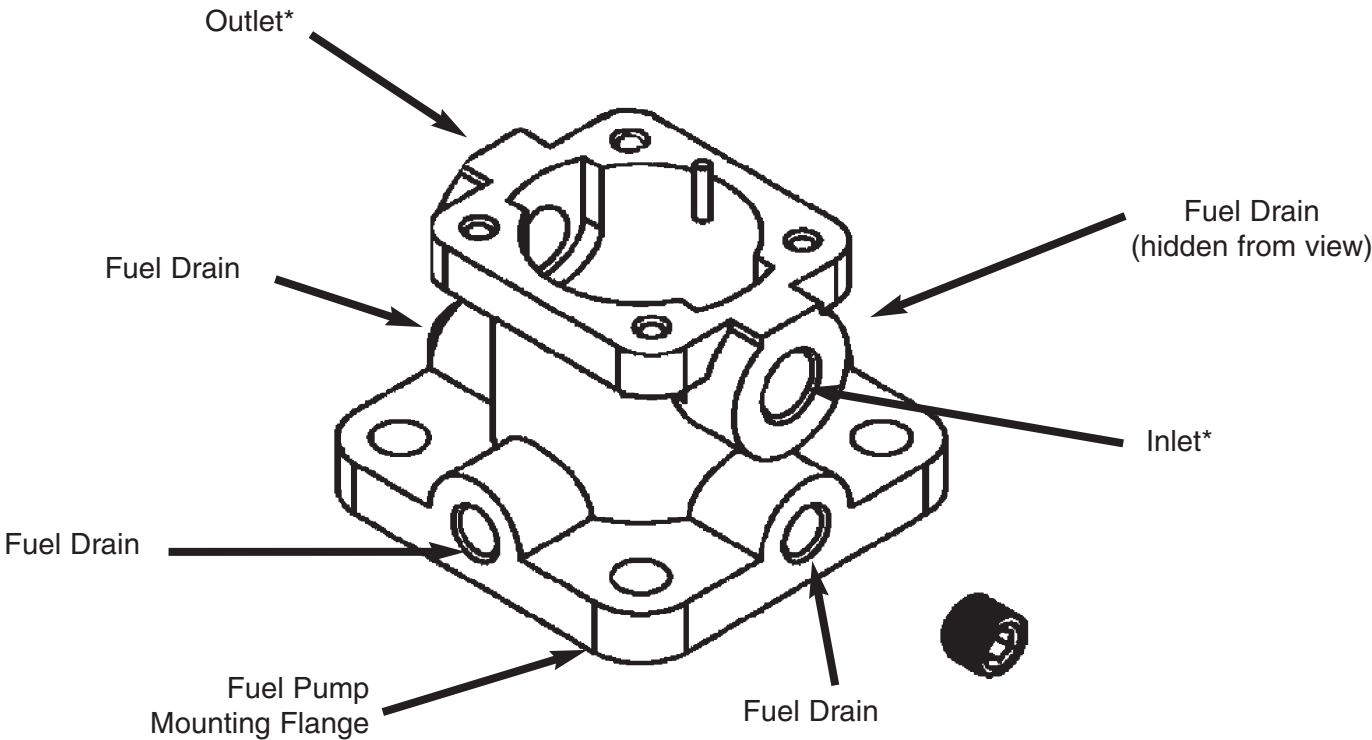
Figure 1 - 201F Inlet / Outlet & Drains

- (2) Manufacturing variations may affect fit resulting in reduced clearance which can heat the rotor causing damage to the shaft seal and/or overload of the pump drive coupling. This condition is more likely to occur on low time units.

- (3) Should the shaft seal leak, lost fuel will be routed to drain ports in the pump mounting flange. See Figure 1. The fuel may be conducted overboard via the airframe provided fuel drain system.

- (b) Locate the fuel pump overboard drain line connection on the mounting flange and disconnect the aircraft overboard fuel drain line from the fitting. See Figure 1.
