# Service Bulletin

## Service Bulletin No. 084

### 200F & 202F Fuel Pump Rotor Inspection

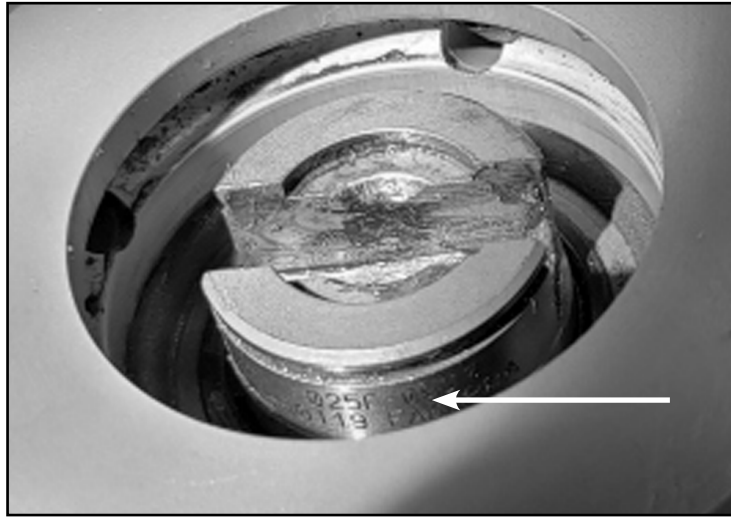
Figure 2 - Rotor Inspection -  
Retaining Ring (6) and Drive  
Coupling (5) Removed

- (1) Prior to forwarding an affected fuel pump to an authorized repair facility, perform the following inspection of the fuel pump rotor.
  - (a) Remove cooling shroud (if required) and fuel pump from the engine in accordance with engine and airframe service instructions.
  - (b) Remove retaining ring (6, Figure 1) and drive coupling (5) from the fuel pump. Discard retaining ring (6) and drive coupling (5).
- (2) Inspect the OD of the rotor shaft (Figures 2 and 2A) for a rotor inspection marking.
  - (a) If any portion of the rotor inspection marking is visible, the fuel pump is in compliance with this Service Bulletin.

- 1) Install a new drive coupling (5) and retaining ring (6) in accordance with chapter 7 of HET manual 200201-0000 Rev. K or later FAA approved revision.
  - 2) Install fuel pump onto engine in accordance with applicable engine/airframe maintenance manual and service instructions. Continue to 3.D, Return to Service.
- (b) If the factory inspection marking **is not visible**, continue to 3.C, Corrective Action.
