Alert Service Bulletin No. 076

200F, 201F, 202F Fuel Pump Leak Inspection and Diaphragm Replacement

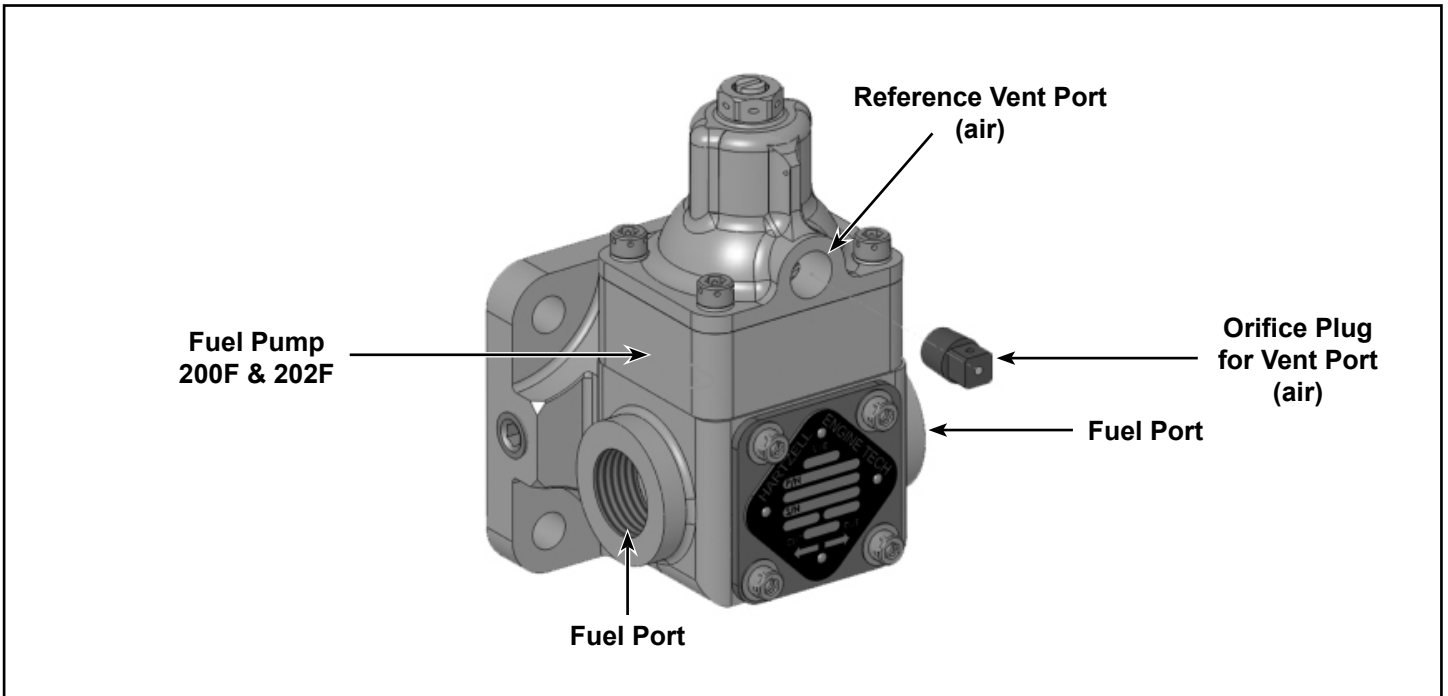
Figure 1 - 200F & 202F Identification

- (a) Inspection of the orifice plug requires only a visual inspection. Look around the plug and into the orifice for fuel or blue dye stains. Refer to Fig. 1 or Fig. 2.

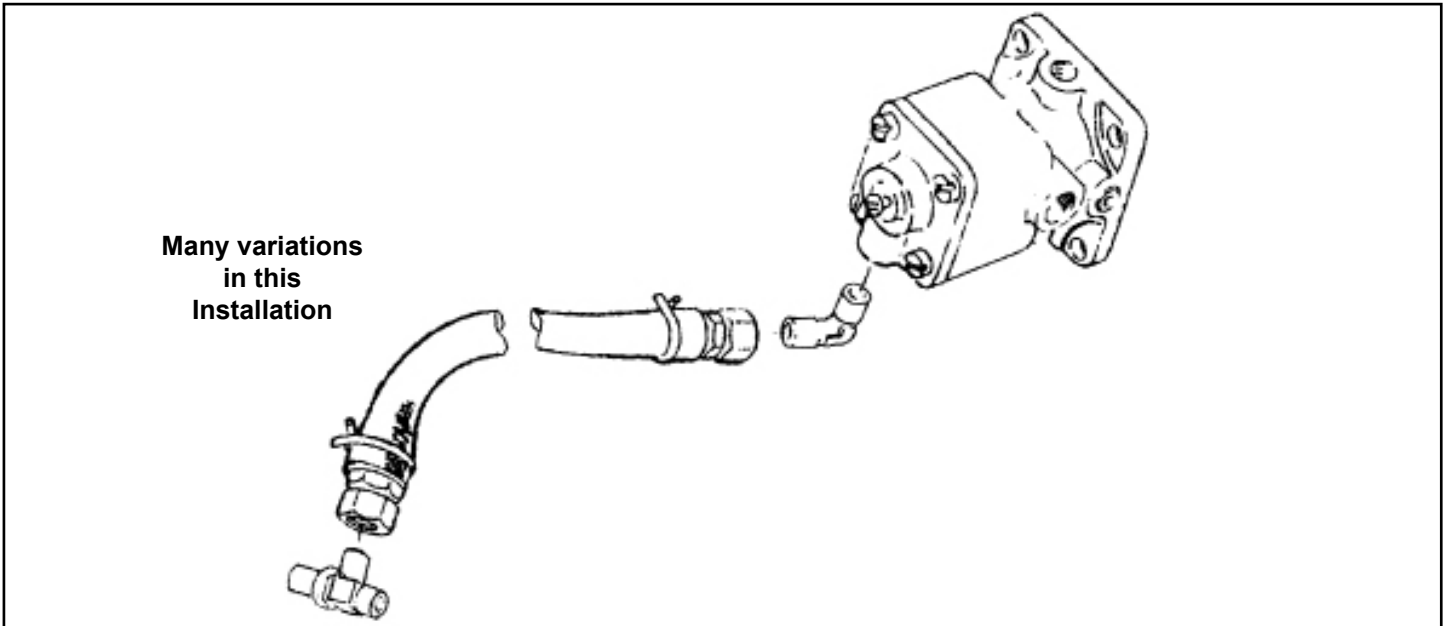
Figure 5 - Typical HET 201F Fuel Pump Plumbed to Upper Deck Reference

- (b) Inspection of the upper deck reference line requires that the line be disconnected and the inside of the fitting be inspected for fuel or blue dye stains. Refer to Fig. 5 and 6.
