Alert Service Bulletin No. 098

200F & 202F Fuel Pump Leak Inspection

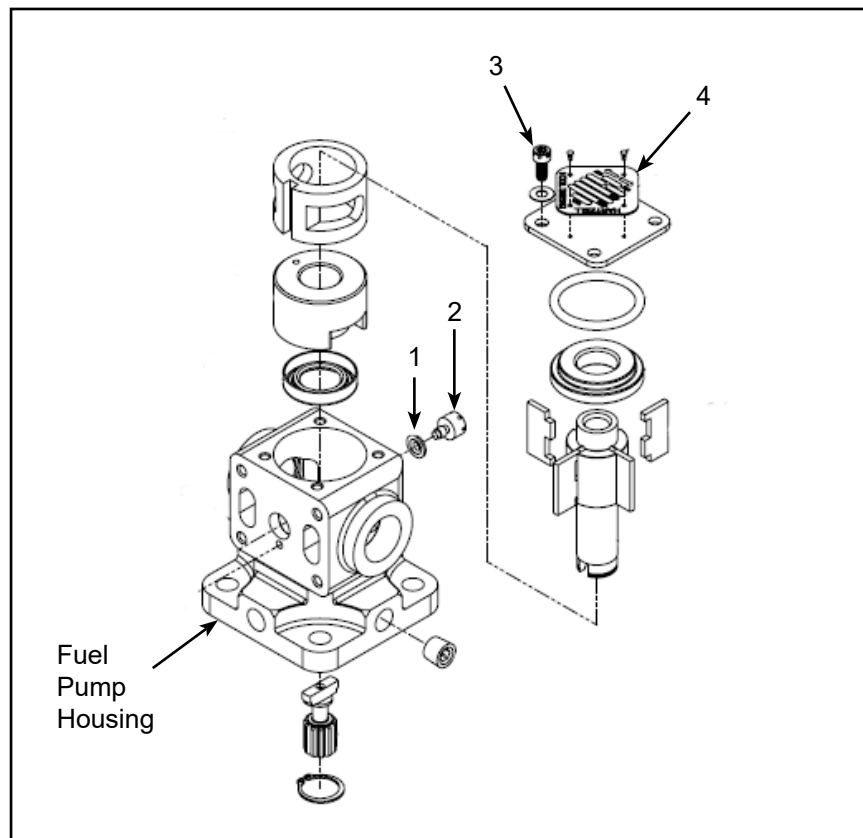
Figure 1 - Pump Housing

- (1) Affected 200F and 202F series fuel pumps may contain a washer and O-ring assembly (1) where the sealing washer for the set screw (2) is not fully seated, potentially resulting in a leak.
 - (a) This condition may cause a fuel leak from the set screw (2) orifice and could result in an accumulation of flammable fuel in the engine cowl.

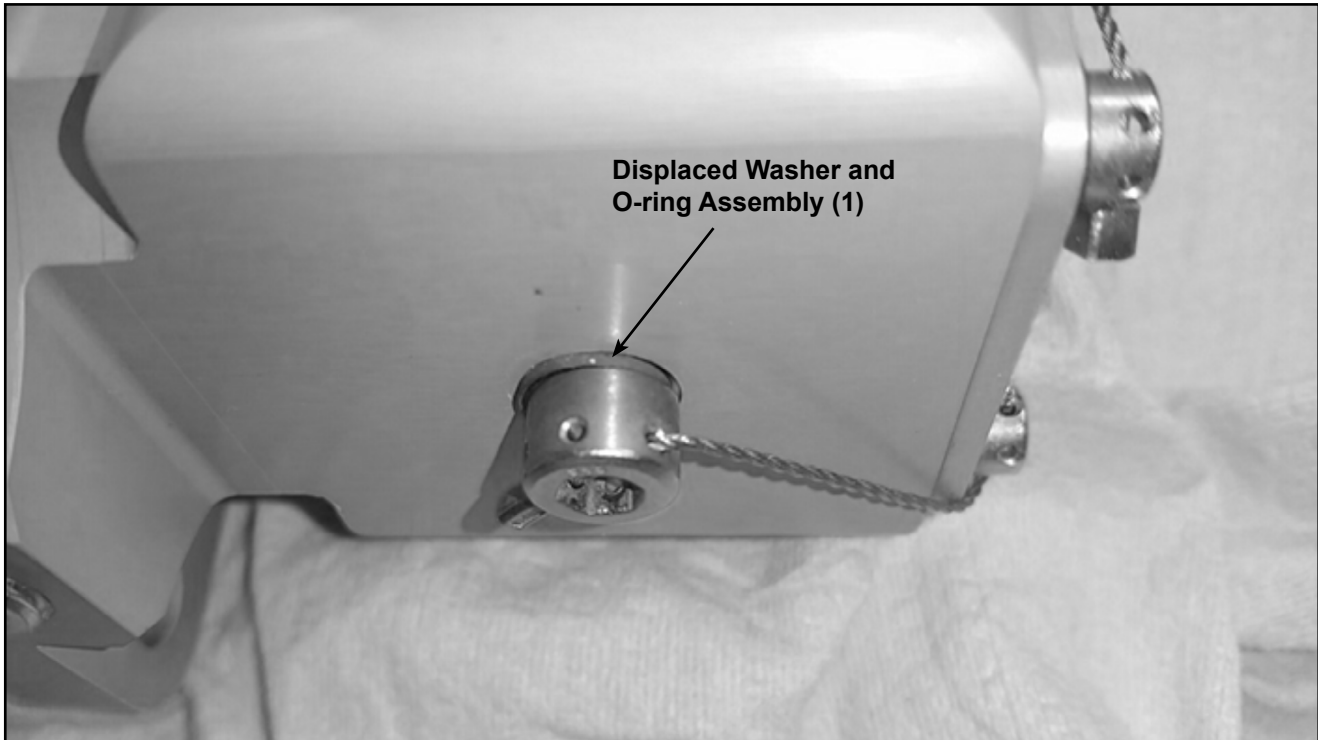
- (1) Perform the following inspection of the fuel pump set screw (2).
 - (a) Gain access to the fuel pump, remove cooling shroud, if required.
 - (b) Perform a detailed visual inspection of the set screw (2) for washer and O-ring assembly (1) displacement as shown in Figure 2. Inspect immediate and surrounding areas for signs of fuel leakage, such as blue staining.

Figure 2 - Displaced Washer and O-ring Assembly

- (a) Remove cooling shroud (if required) and fuel pump from engine in accordance with engine and airframe service instructions.
- (b) Take note of safety wire routing and then remove safety wire and discard. Remove the set screw and washer assembly from the fuel pump and discard.

- (c) Obtain a new set screw and washer assembly. See Section 2, Materials Required.
- (d) Apply Chemplex 710 to both sides of the washer and inner diameter. Carefully insert set screw into washer bore, ensuring no damage occurs to the washer elastomer.

- (e) Verify the liner indexing notch is centered with the threaded hole. A non-marring tool may be used to adjust the centering of the liner, taking care to avoid damage to the threaded hole.

- (f) Insert set screw into threaded hole and hand tighten until washer has made contact with housing spot face. Inspect to ensure washer edge is not overlapping spotface shoulder. If any resistance or bottoming out is observed during set screw installation, back out the set screw and inspect screw threads and housing threads for damage and inspect for liner alignment.

- (g) If installation is acceptable, torque set screw to 10-12 in-lbs.
- (h) Safety wire following the original pattern using .032 safety wire or Daniels .032 Safe-T- Cable.

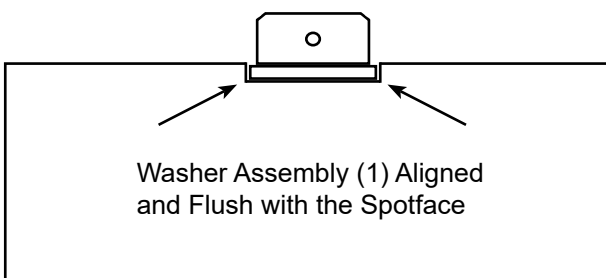
NOTE: The washer (1) OD must rest within the perimeter of the spotface relief and must **NOT** bridge the perimeter of the spotface relief at any point. See Figures 3 & 4.

Figure 3 - **Acceptable** Set Screw and Washer Assembly Alignment

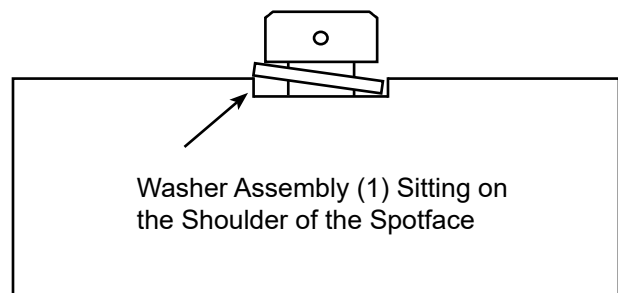
Figure 4 - **Non-Acceptable** Set Screw and Washer Assembly Alignment
